Orion Inspection Planning - Lessons Learned

**J. Michael Rollins Image Science and Analysis
Group (ISAG, JSC/KX, JETS contract)
john.m.rollins@nasa.gov (281-483-1262)
2014 In-space Inspection Workshop**

Inspection of Orion at ISS

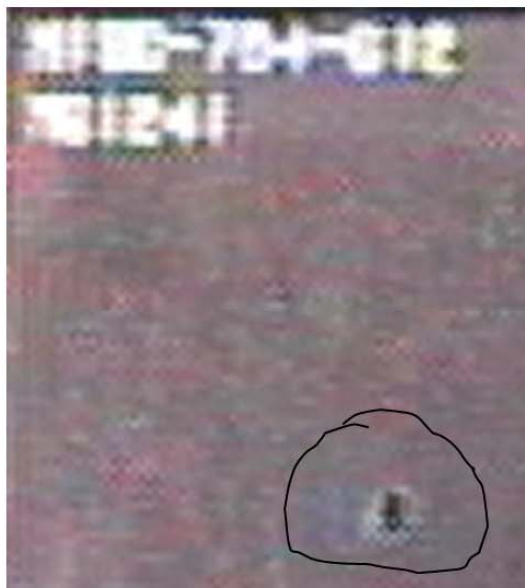
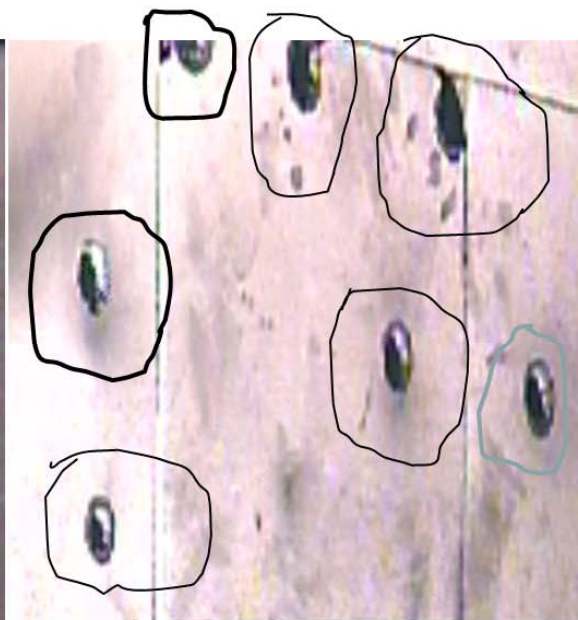
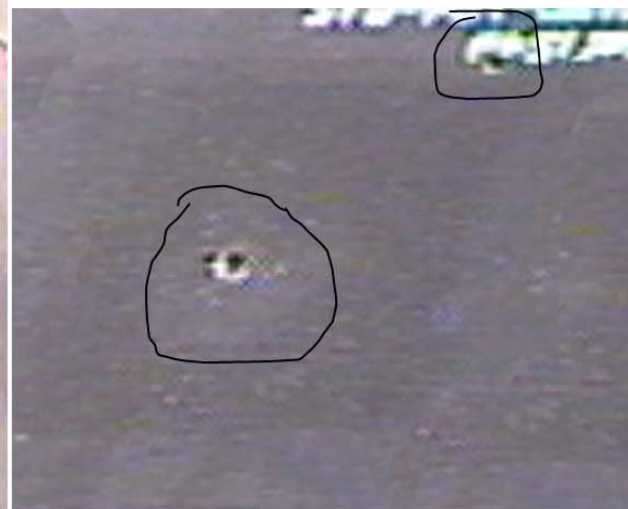
Sample MSS Camera Imagery under Mock Solar Illumination, with Screener Annotations

Example screener-annotated slide from a damage detection blind study in the Fall of 2010. The MSS images were captured under conditions equivalent to 10' range at full zoom (7.7 mm focal length) and simulated sunlight or MSS artificial illumination. The images were all subject to the degradation associated with the mockup ISS Video Baseband Signal Processor (VBSP)* which discarded an entire field of information (and therefore half of the vertical resolution). In 2013, the VBSP was replaced with newer technology with improved downlinked image quality.

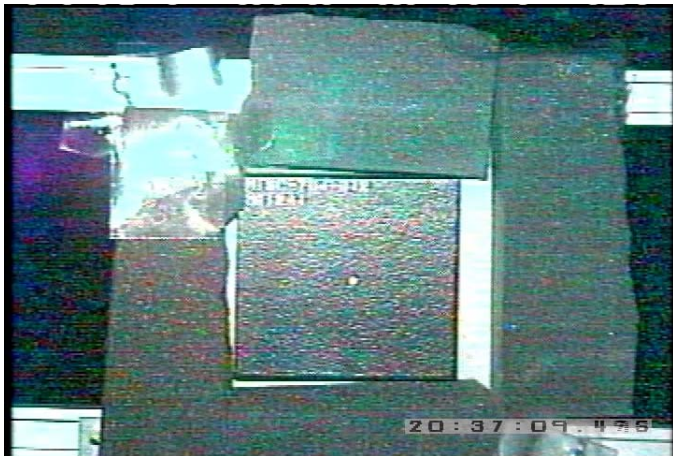
SSRMS and Dextre MSS-type Imager with Relevant* Line-of-sight (LOS) Illumination

Internal silica glows against entry hole rim, for both black and white (painted) tiles, given line-of-sight illumination. This gives evidence that **an actual entry hole is present**, and the suspect feature is not missed or considered just a blemish.

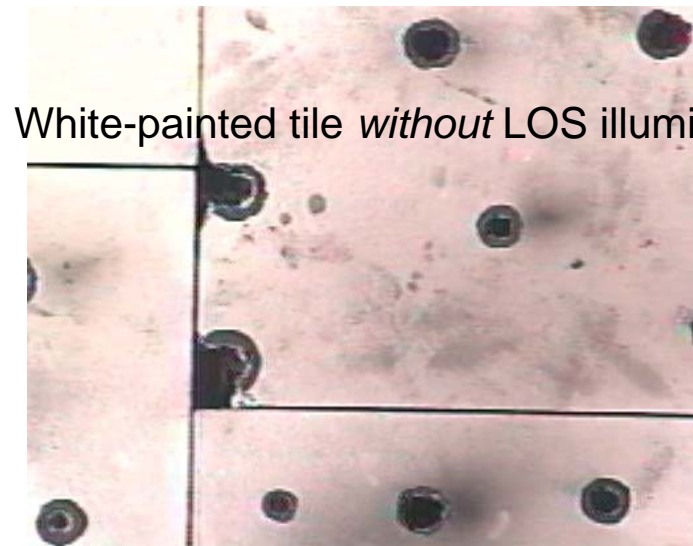
White-painted tile *without* LOS illumination
